Final Report of the Silicon Lifetime Committee

The Silicon Lifetime Committee was charged with systematically identifying limitations to the operational lifetime of the present silicon detectors, SVX II, ISL, and L00. In this note the work and conclusions of this committee are summarized.

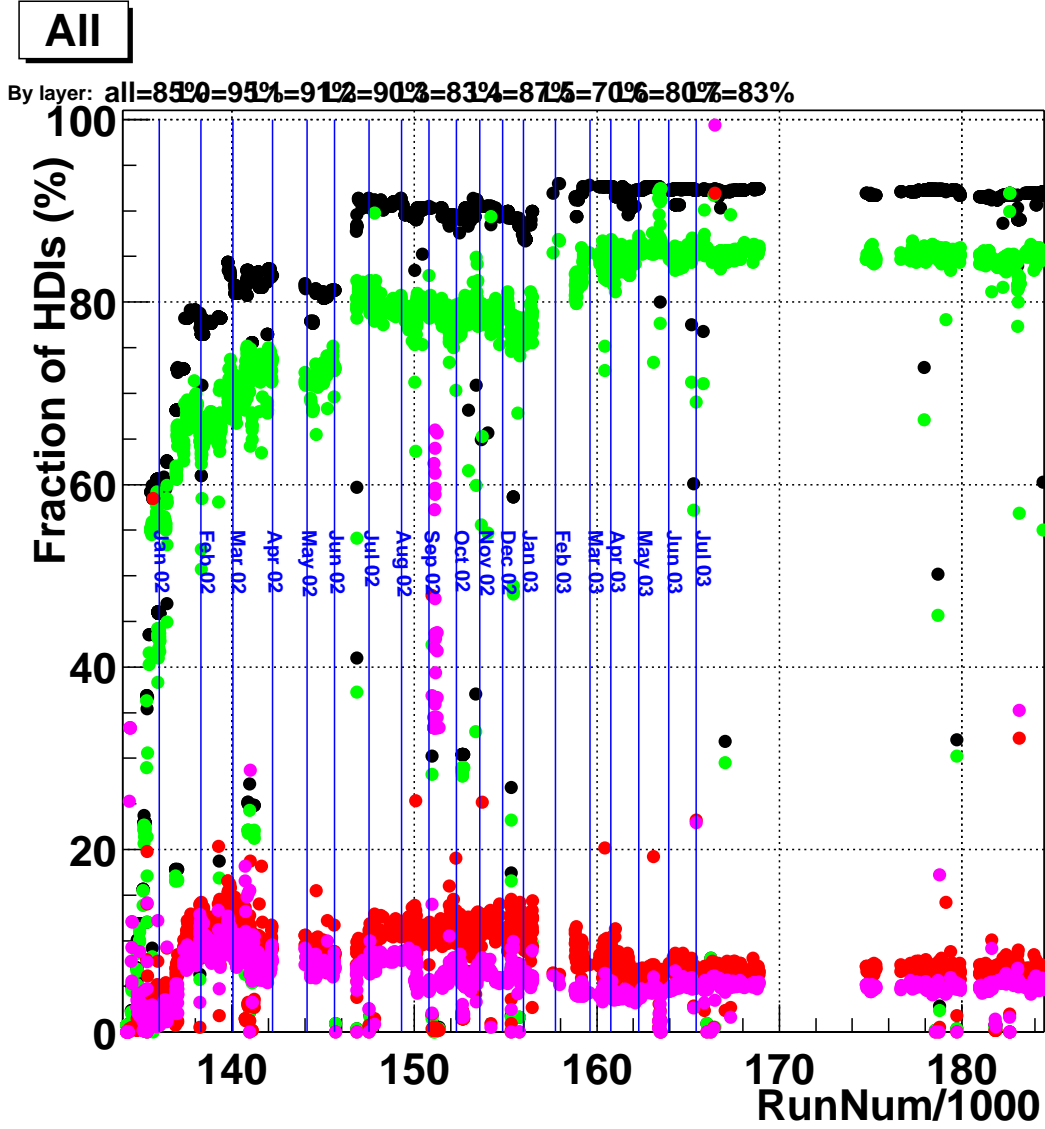
Over the last few years the silicon operations sub-project leaders (SPL) have been keeping close track of chip failures in the silicon detectors. Figure 1 shows the fraction of each detector that has been integrated into data-taking as a function of time beginning in Jan-2002. After the commissioning ramp-up approximately 92%, 85% and 95% of the SVX II, ISL and L00, respectively, have been steadily taking data. Each failure is categorized as it becomes understood. It is important to keep track of failure trends in order to spot those categories which continue to grow. In Figures 2 to 4 the damage histories for the SVX II and ISL are shown. In each figure, the fraction of chips which are inoperable (*i.e.* unable to take (good) data) is plotted as a function of time. The various sources of damage are broken-out into separate curves. We briefly discuss these figures below.

Figure 1: Fraction of HDIs integrated into data-taking as a function of run number. The black dots indicate the fraction of HDIs integrated into data-taking, while the green dots indicated that fraction of HDIs integrated into data-taking which yield $< 1\%$ readout errors. The red and pink dots keep track of bad ladders and error rates, respectively.

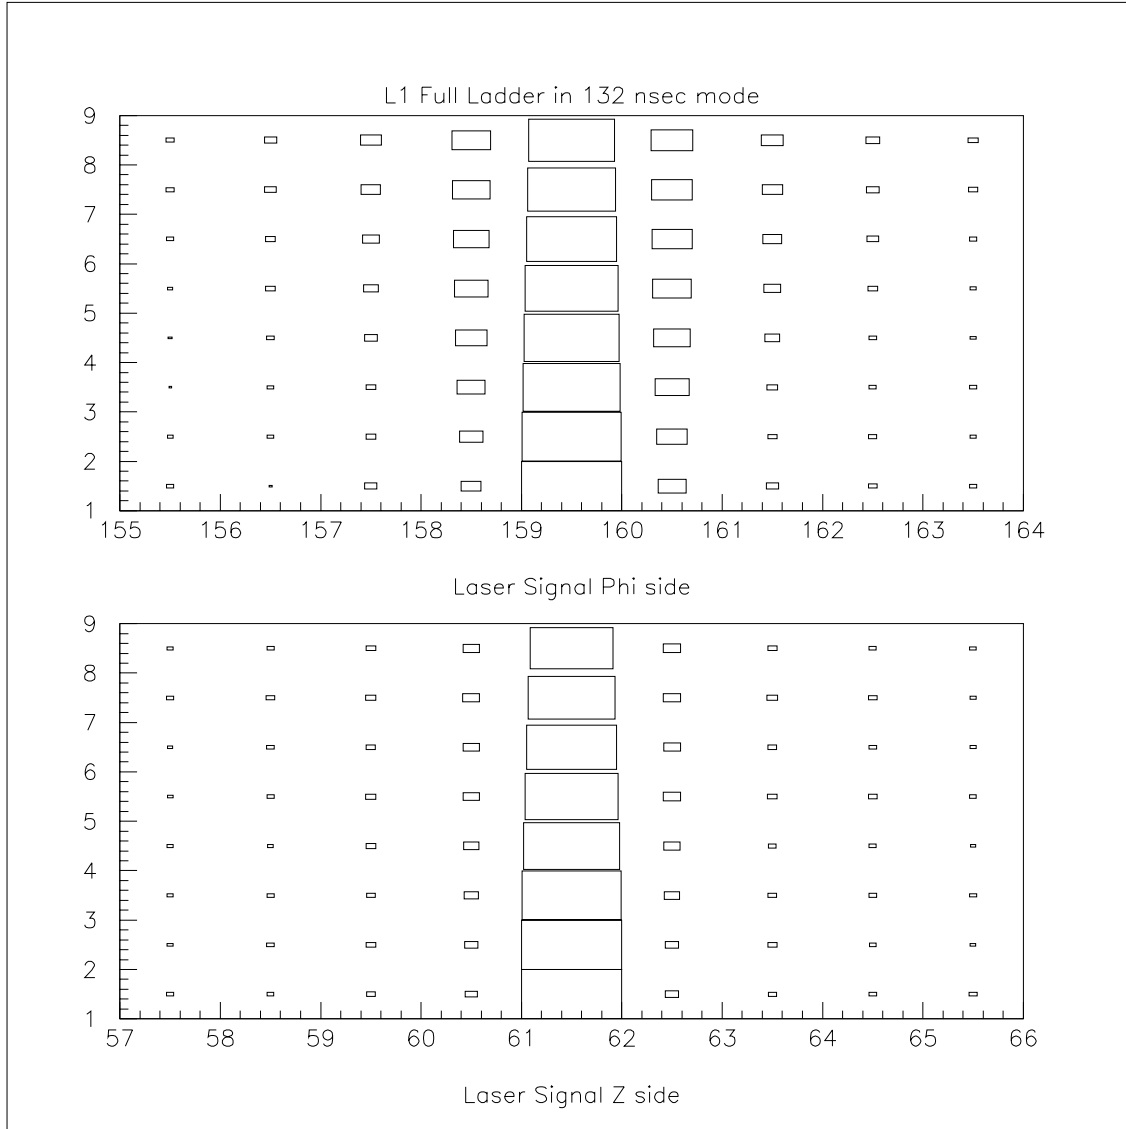
nsec bunch spacing has been canceled. The CDF silicon system FECLK cycle is still 132 nsec. There are potential advantages and disadvantages on changing the silicon integration time from 132 to 396 nsec. By comparing Figures 6 and 7 it is clear that the charge sharing is worse for the 132 ns FECLK. This additional charge sharing affects the distribution of the collected charge and consequently the single hit resolution. This effect is reduced if the integration time is increased to 380 nsec.

Figure 6: Laser induced signal on a layer 1 SVX II ladder. The X axis is the channel number while the Y axis is the BW settings. These plots correspond a 140 nsec FECLK cycle (120 nsec integration time) and should be compared to the corresponding plots made with a 400 nsec FECLK as shown in Fig 7.

- > Chose a subset of ladders in the innermost SVX II layer and measure the signal-to-noise ratio for the default and the maximum integrator current settings.
- > Depending on the results expand the changes to the other ladders of the same layer.

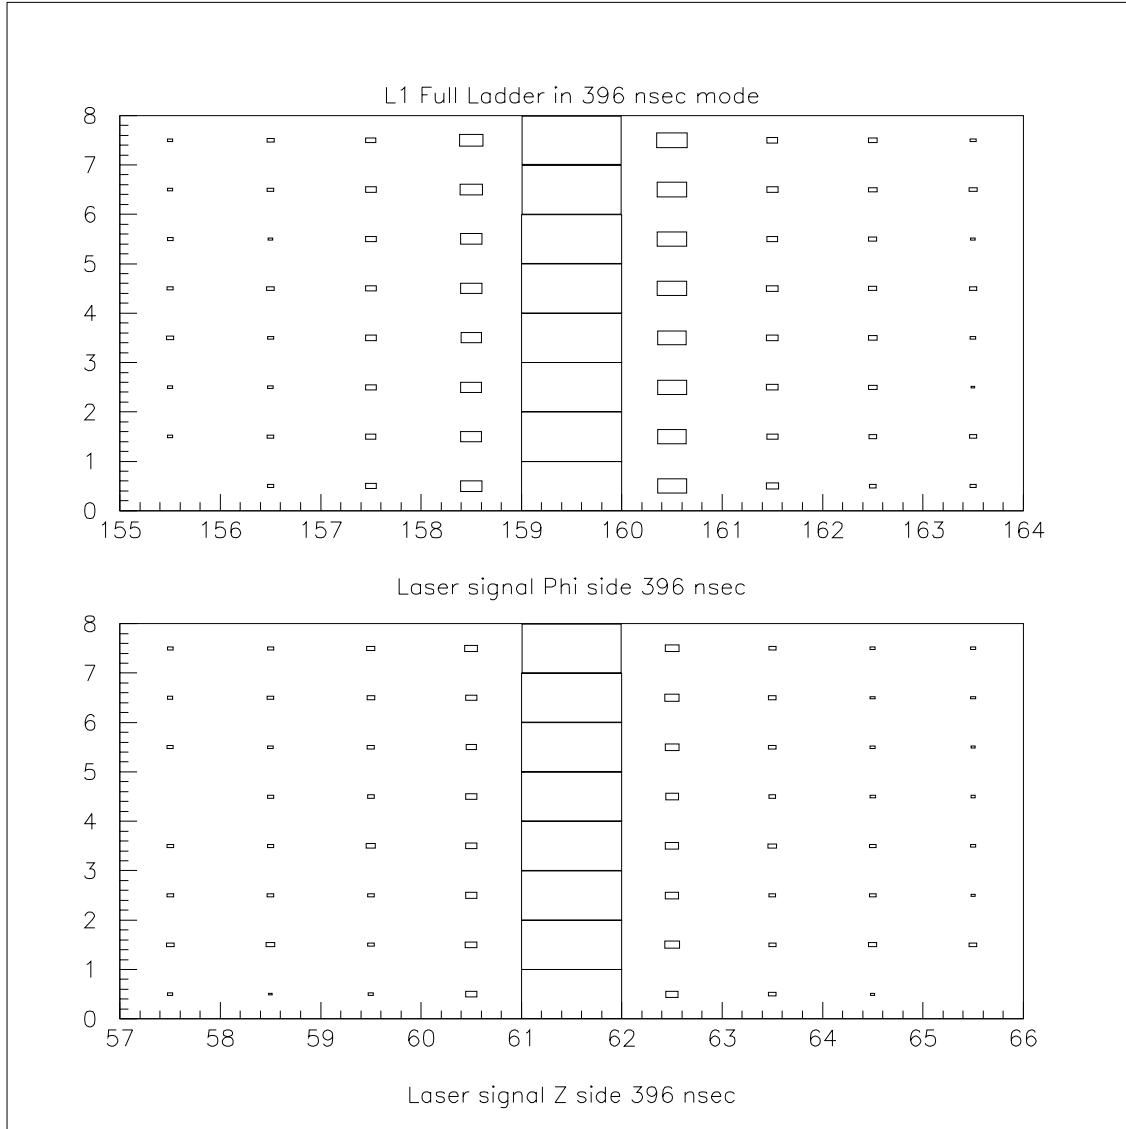
Figure 7: Laser induced signal on a layer 1 SVX II ladder. The X axis is the channel number while the Y axis is the BW settings. These plots correspond a 400 nsec FECLK cycle (380 nsec integration time) and should be compared to the corresponding plots made with a 140 nsec FECLK as shown in Fig 6.
